Pop Ash Creek Preserve Natural Resources Project Update 6-15-2011

The following pictures show some of the changes that have taken place out at Pop Ash creek Preserve from the Natural Resources Hydrologic Restoration Project. Keep visiting the website and we will update with more photos as the work progresses.

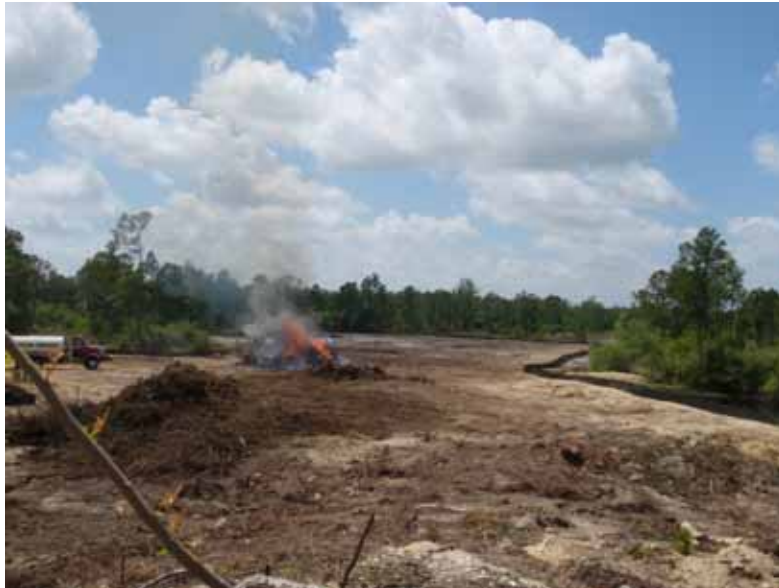
Photo #1 taken at the top of a HUGE dirt pile that was covered in Brazilian pepper. The contractors have been able to burn much of the vegetation that needed to be cleared. The ashes will be saved, along with the top soil for plantings.

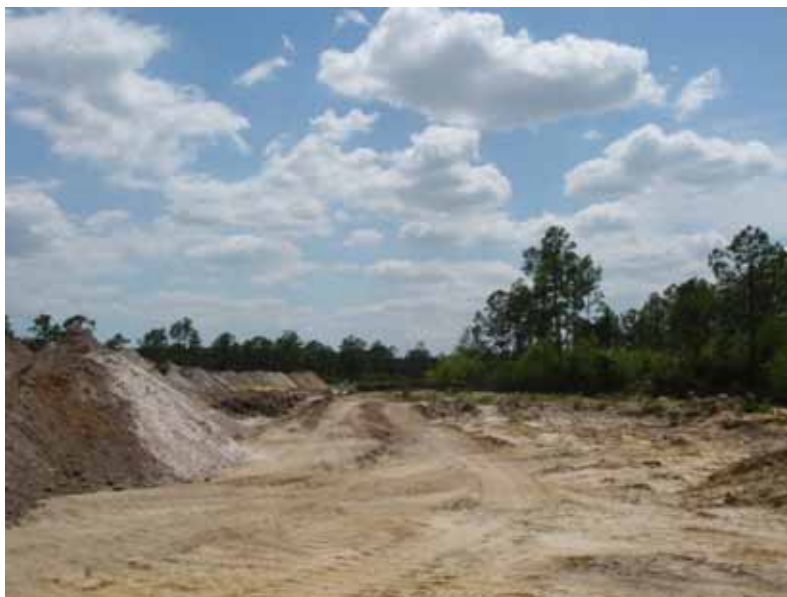
Currently, the contractors are storing extra dirt from the project in this area.

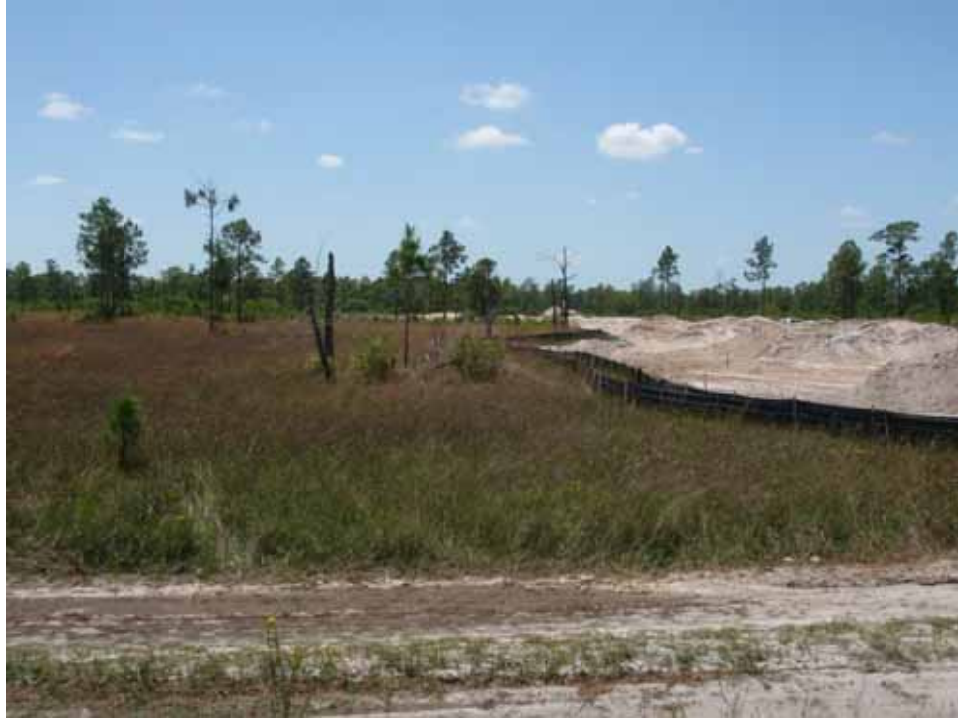
Photo #2, top soil returned to the flow way for the plantings. At this point it hasn't been spread out yet.

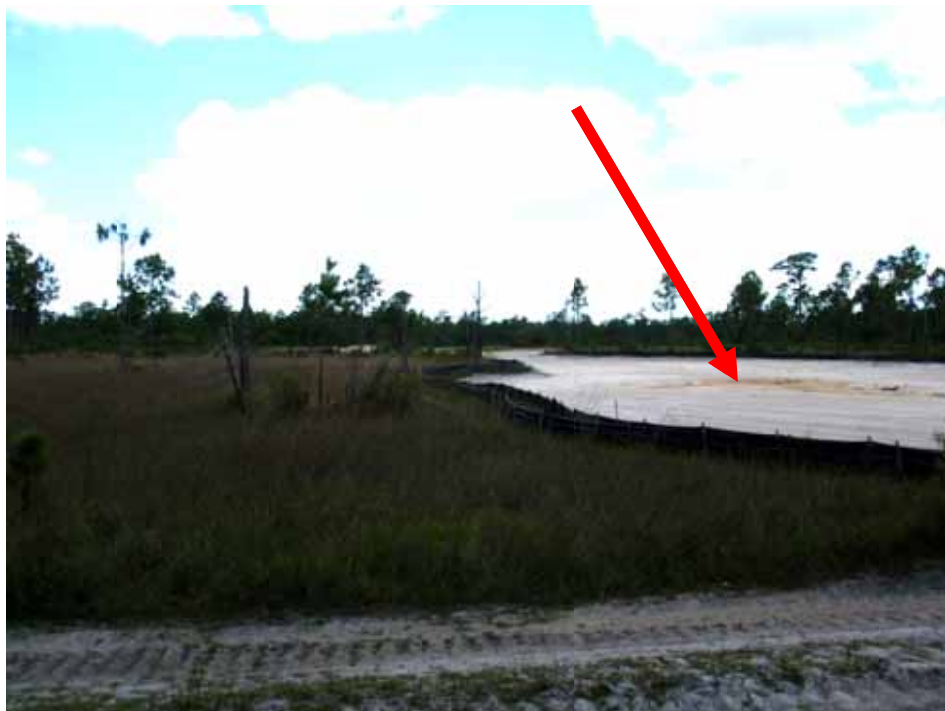
Photo #2, the top soil has been spread out to its final elevation. They have also installed several "fish traps" (red arrow). They are slightly lower areas that will hold water for longer periods, trapping fish for birds to eat.

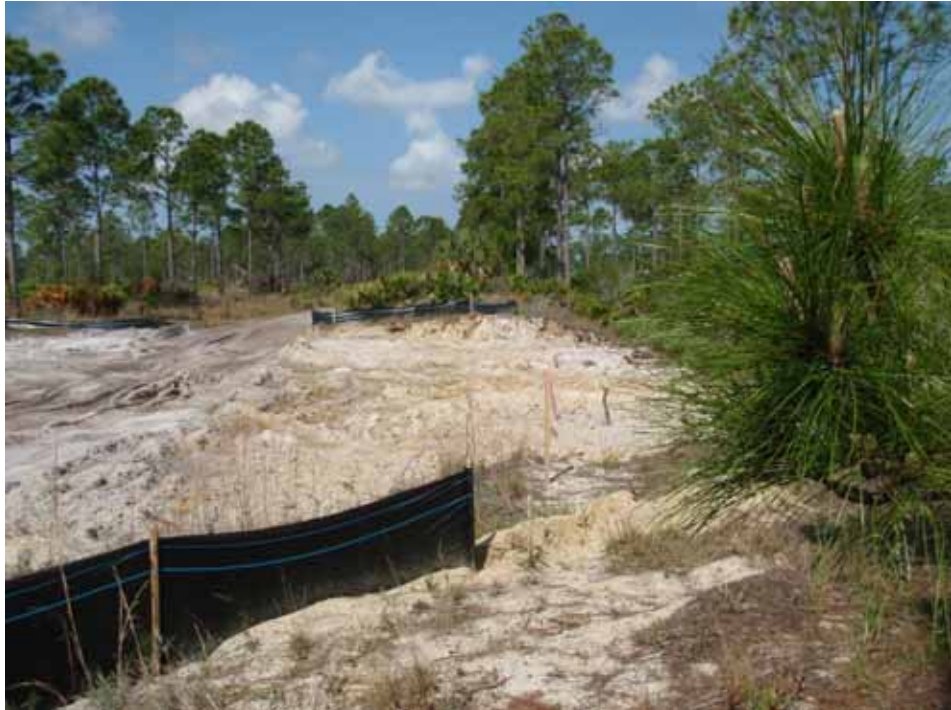
Photo #3 if you look closely on the left side, the shallow flowway has been excavated.

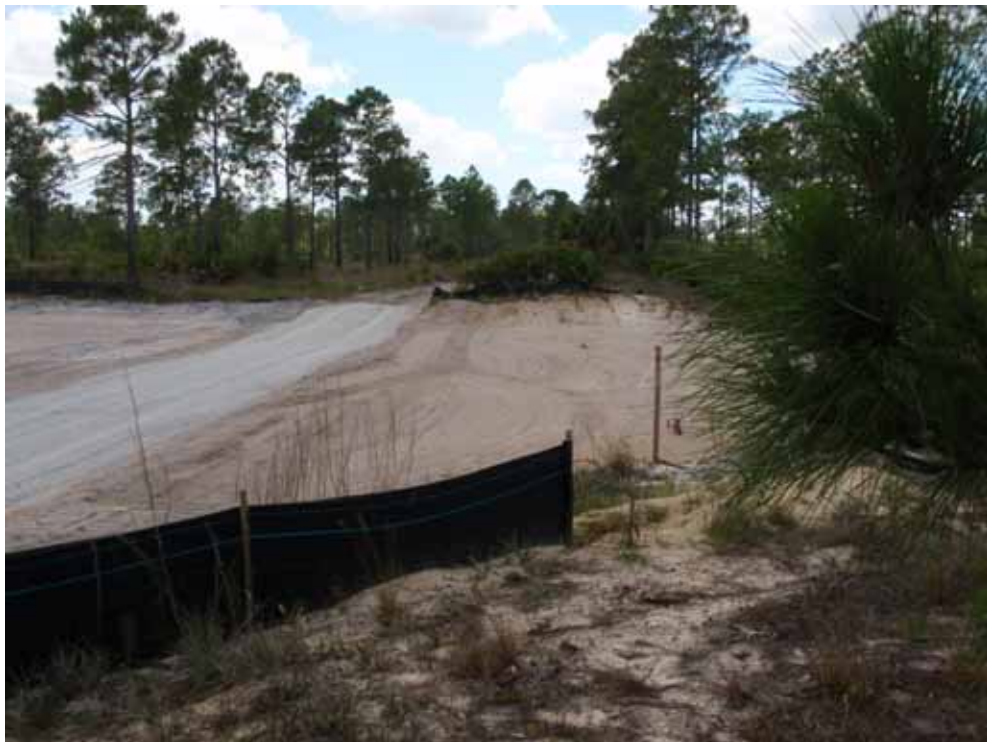
Photo #3. The flowway is complete and they have installed an equestrian crossing that will give the horses firm footing while crossing the wetland.

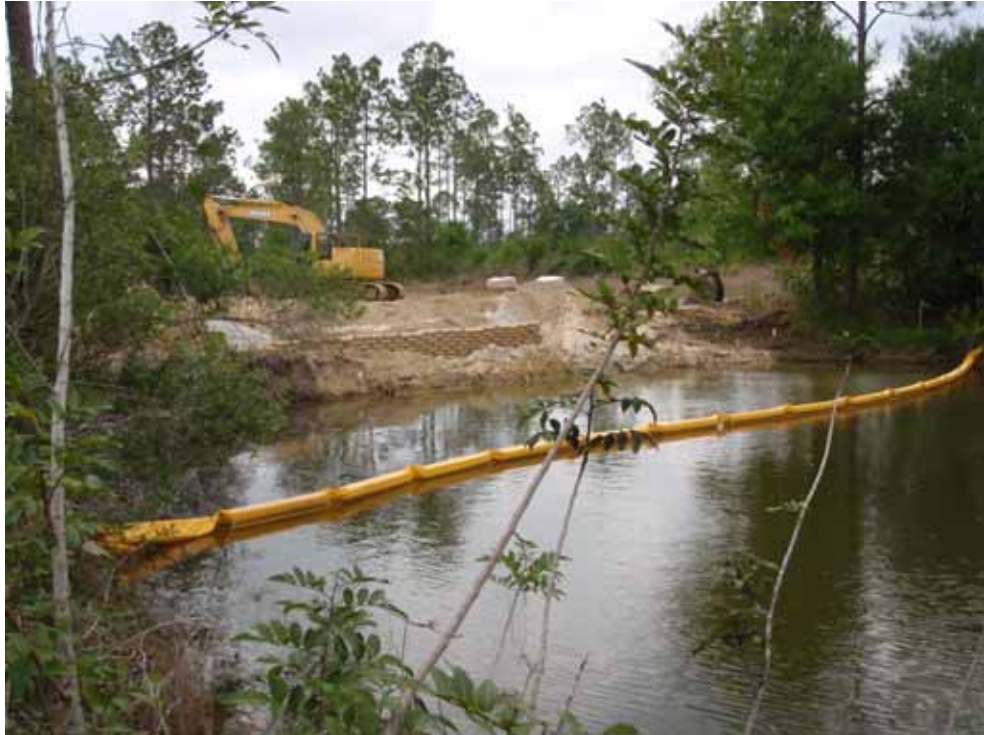
Photo #4. The contractors have placed concrete type bags as a reinforcement wall.

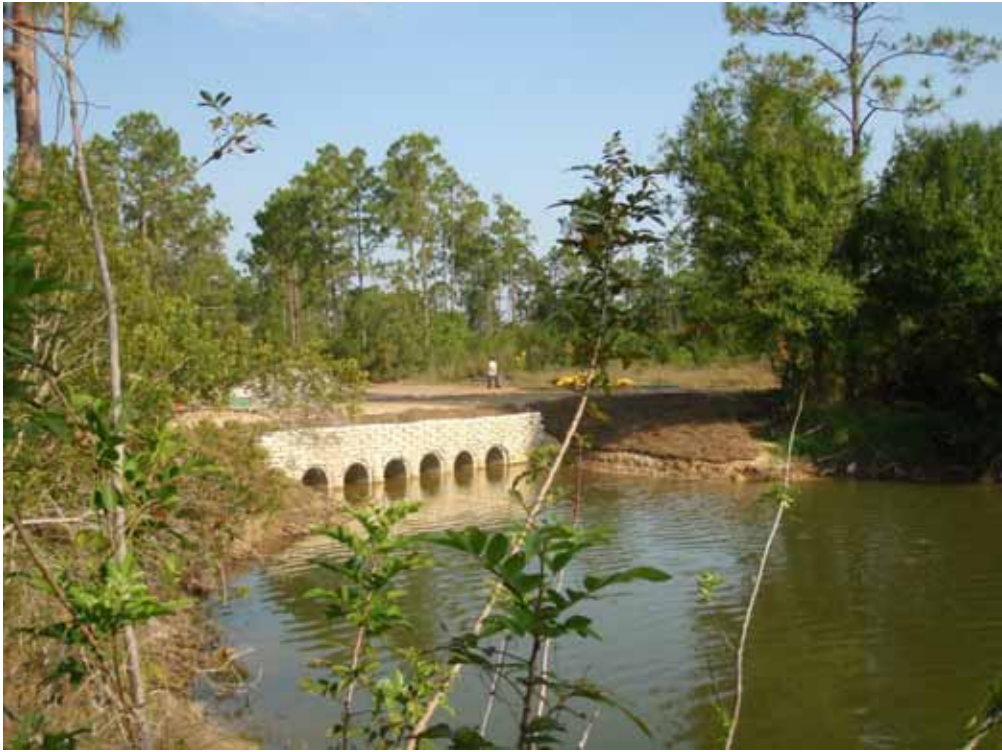
Photo #4. The connection between the "nose" of dolphin pond and the rest of the ponds is complete.

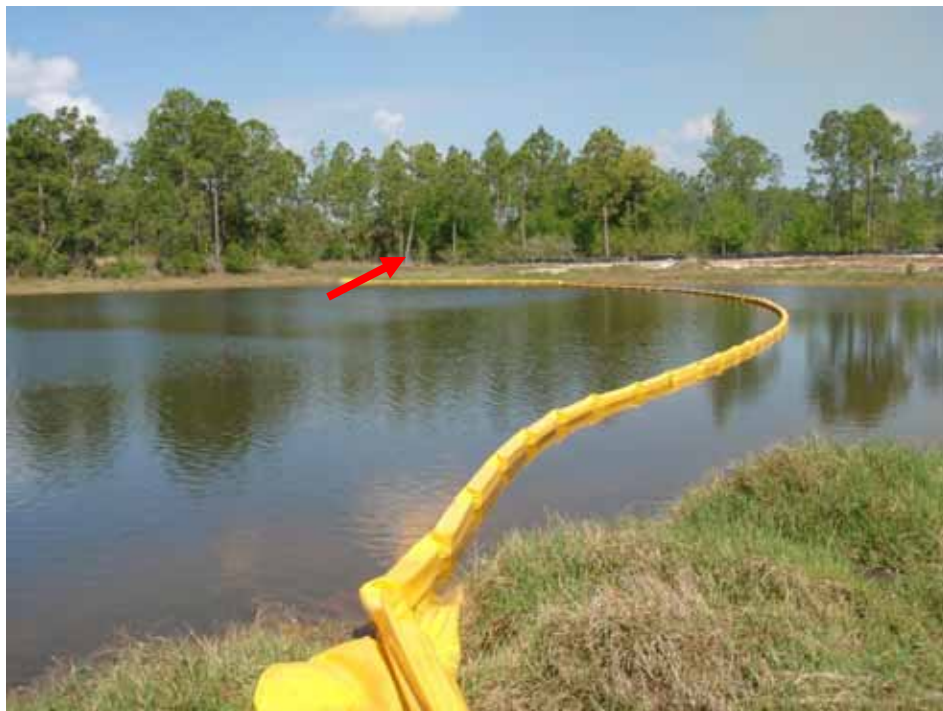
Photo #5 taken from the rectangle pond which has had a shallow flow ways leading from Pop Ash creek and into the pond system. There is a double-trunked pine for reference (although it is hard to see)

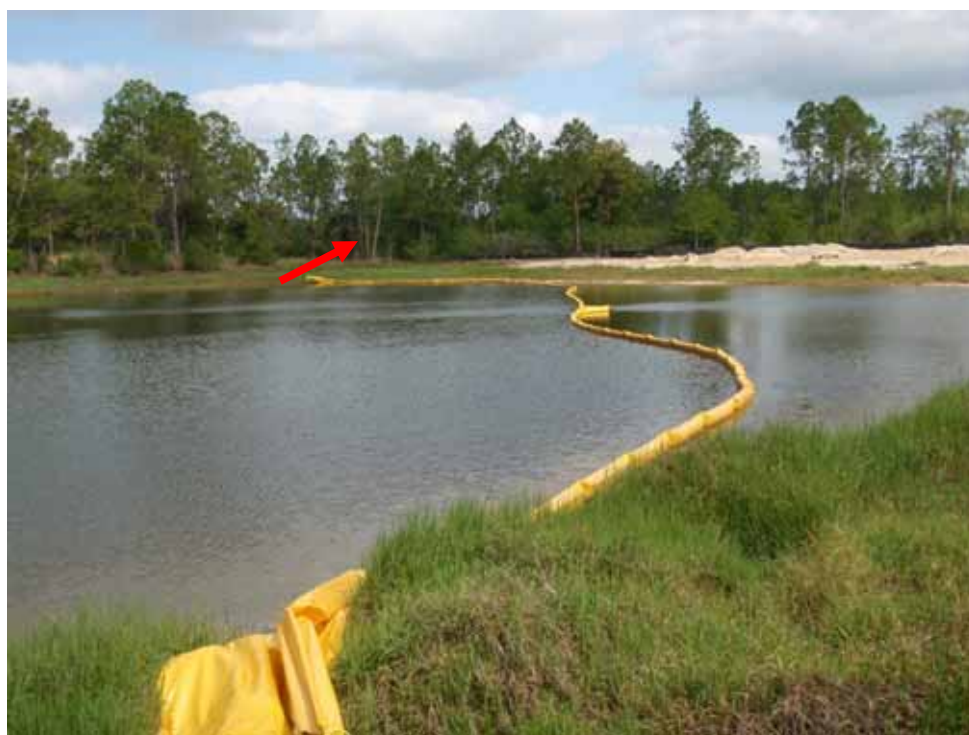
Photo #5 after like photo #2, top soil is waiting to be spread out.

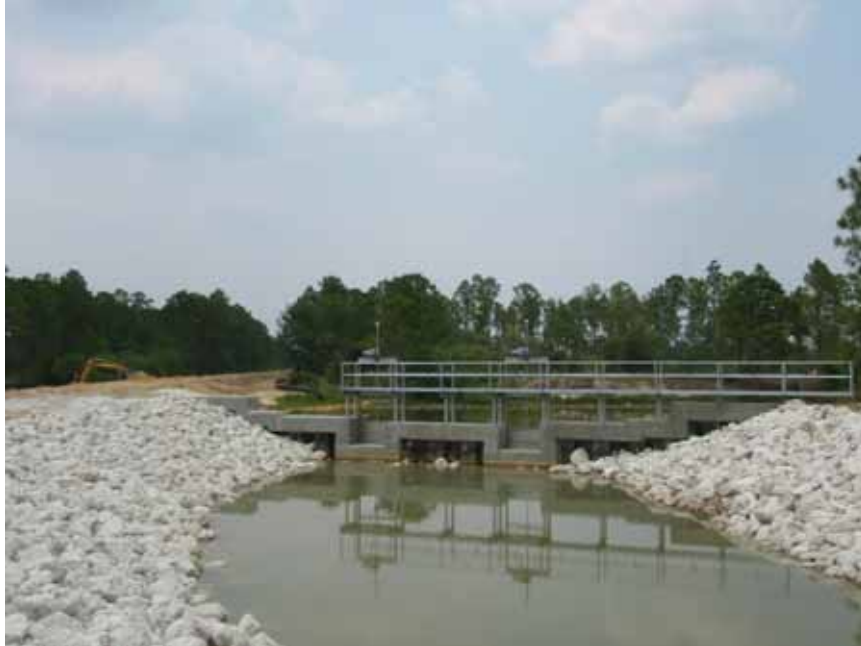
Photo #6 the weir is complete and tons of rip-rap (rocks) have been installed on the banks to stabilize the soil. The rocks also work to slow down the water flow so that the water doesn't carve a hole into any of the banks.

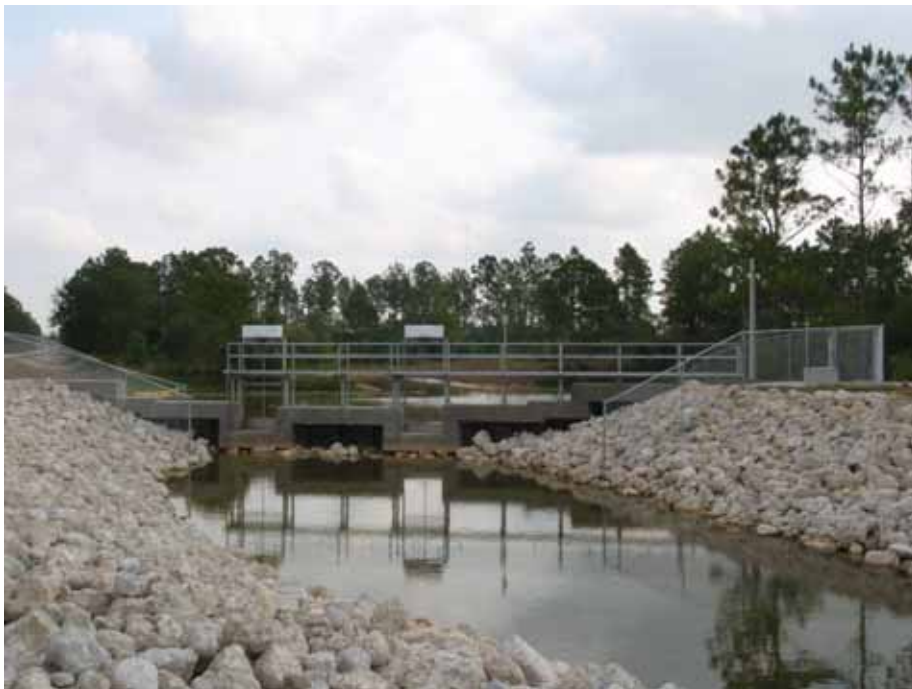
Photo #6. Although it is hard to see in this picture, sod has been planted around the weir. There is also a fence and protective boxes to prevent vandalism.

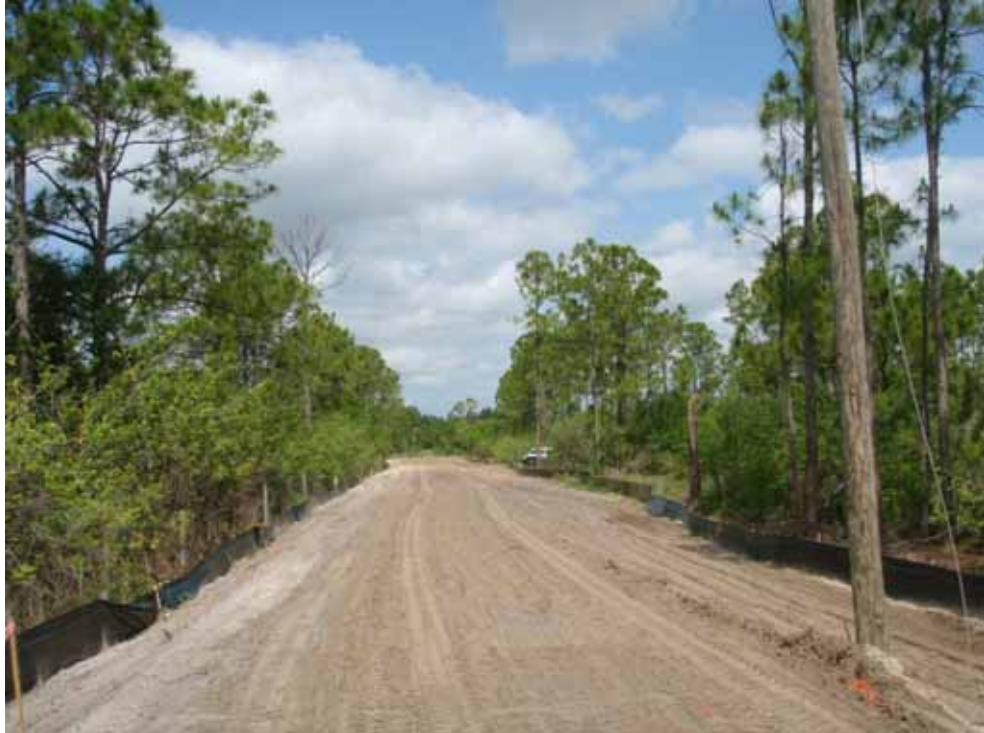
Photo #7 is the southern berm at grade, smoothed out and rocks removed.

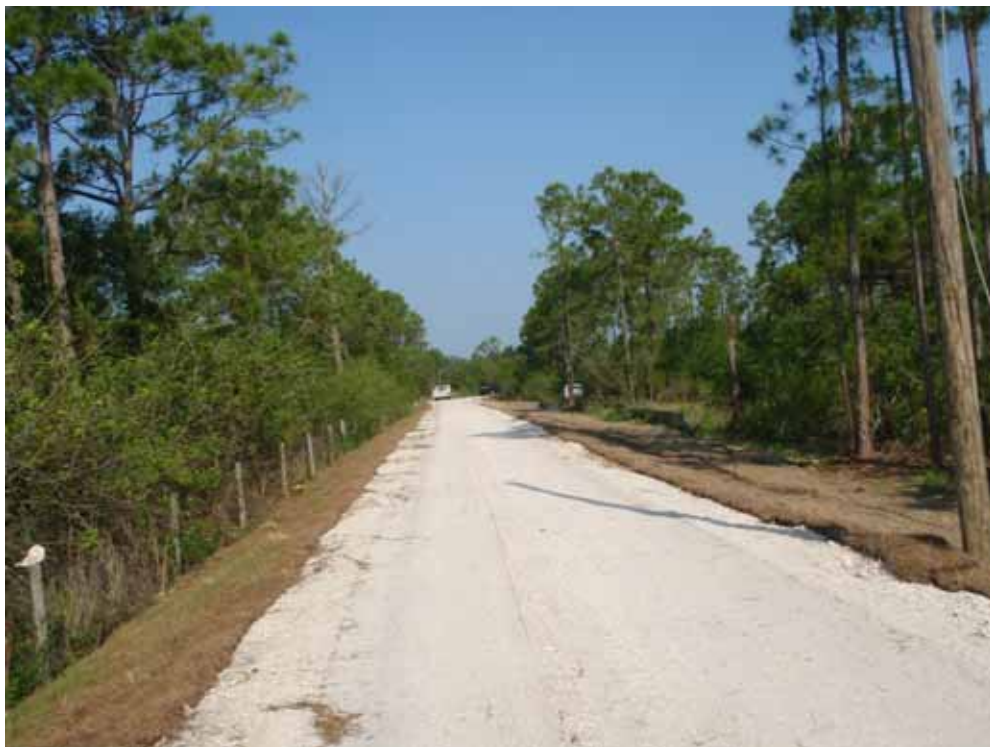
Photo #7. Now the berms are complete. They have put a shell rock on the tops and planted sod on the sides. Hopefully we will get rain soon so that the sod can get established, but for now the contractors are watering it with a truck.

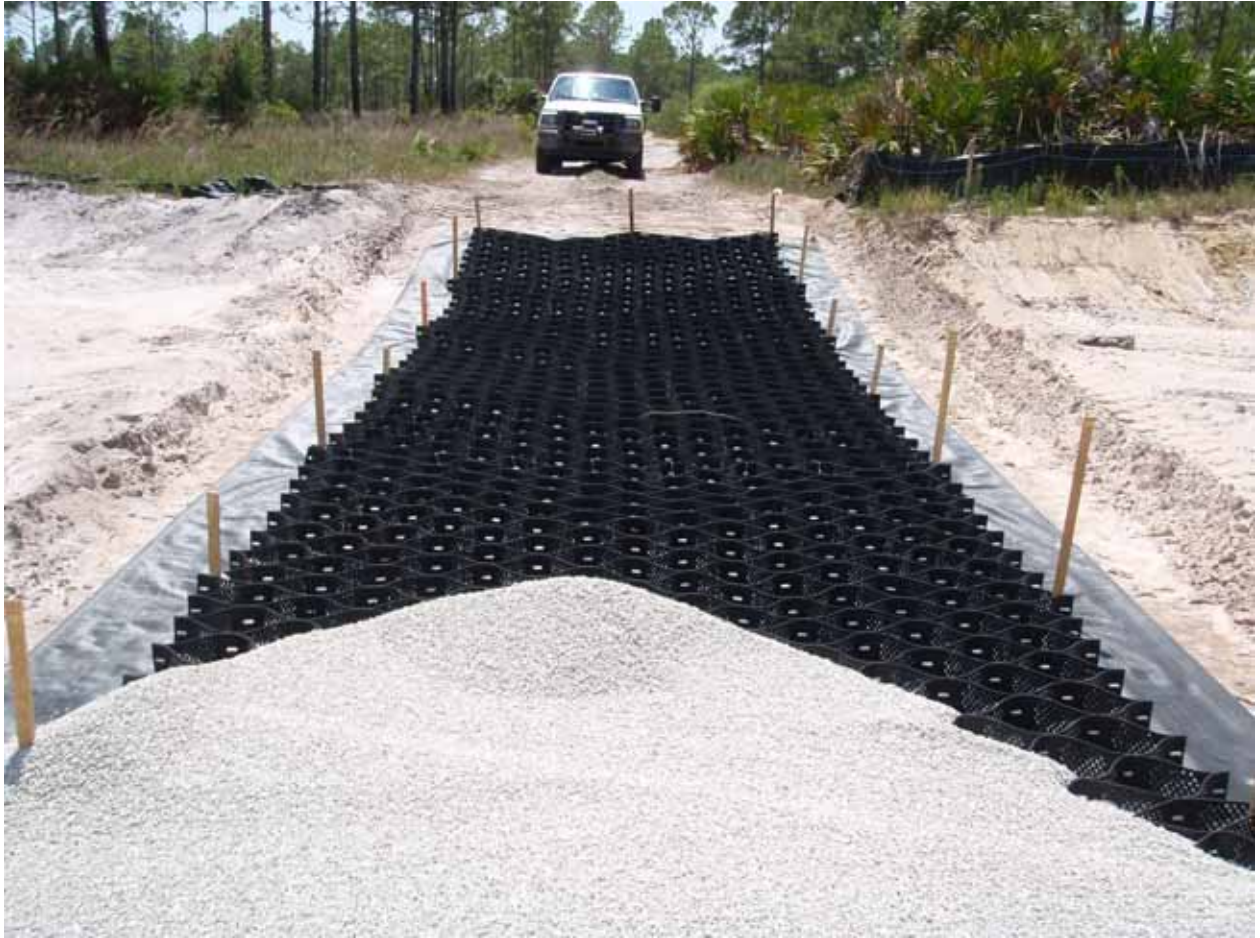
Here is a better view of the equestrian crossing before it was complete. The Geo-webbing will allow for water to flow while providing a stable surface for horseback riders and hikers. Then it is covered with a thick layer of gravel that also allows for water flow and stable footing.

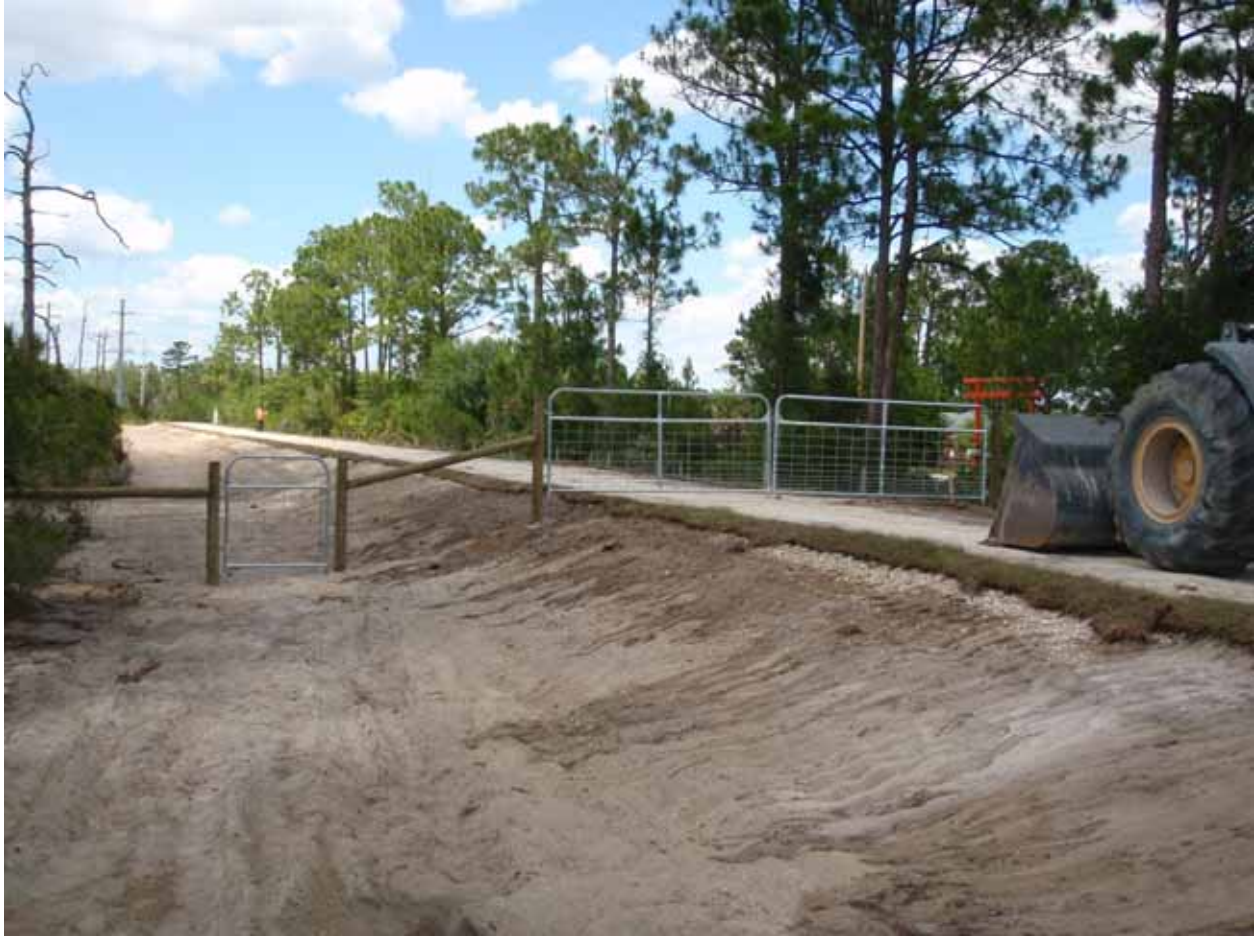
The contractor generously added some additional gates to the project where a fence divides the preserve in half. Now horseback riders and hikers will have several options of where to cross from one half of the preserve to the other. It also should be a little bit drier than the current ditch crossing.
